Quality Assurance Division

Mega Drive 1 VA4 - PAL

008

While using the MD1VA4 with the 32X problems like the screen shaking, game sound slows down and/or the game locks up.

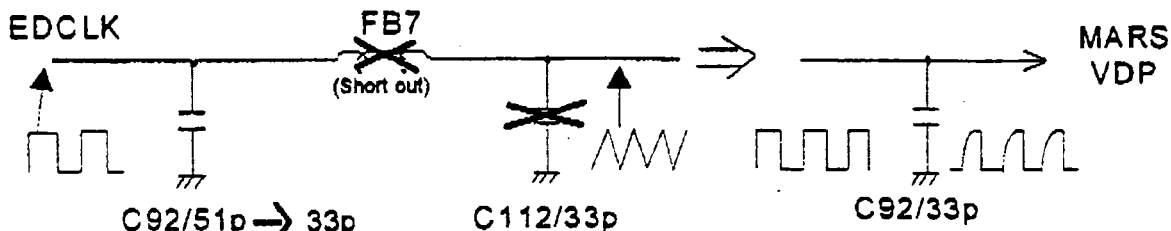
### Circuit Change

While using the MD1VA4 with the 32X at room temperature, it has been found that when certain IC's, capacitors, etc. heat up they cause the screen to shake, slow the game sound and cause the game to freeze.

The signal shape of the EDCLK must be improved to fix this problem, see CIRCUIT CHANGE below.

1. Change C92 from a 51pf capacitor to a 33pf ceramic capacitor. It is important that the capacitor be located next to IC4.
2. Remove FB7 and insert a jumper wire or short out FB7.
3. Remove C112. This is a 33pf ceramic capacitor that has been added to the back side of the circuit board. It is connected to the top side of C19.
4. Add a jumper wire to the back side of the circuit board between the top of C10 (this should be the same point electronically as IC4 pin 31) to ground (the middle pin of EM16 is recommended). Please be sure to use a slightly heavier gage of wire to ground (heavier than AWG28 with a wire diameter of 0.38mm).

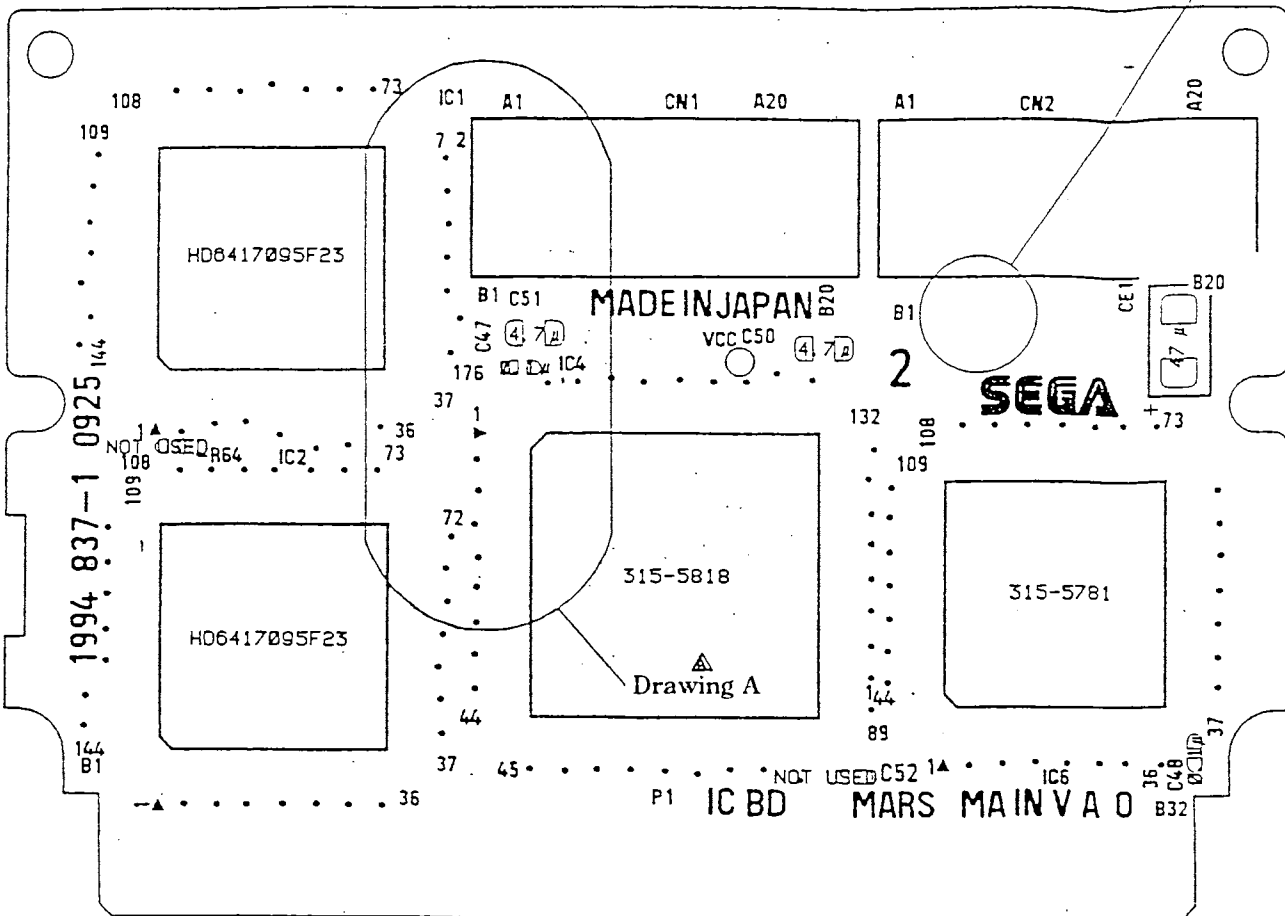
An SCA (Standard Cell Array) type of IC4 has replaced the gate array type originally used on 32X. Due to this change in IC types two capacitors (C96 & C97) have been added. Please refer to the chart below for possible configurations you may encounter.

Value of C96 & C97 depends on part number of IC1/IC2	IC4 (SCA) C96 & C97	IC4 (Gate Array) C96 & C97
IC1 & IC2 Pt# 315-0922	47 pf	NOT INSTALLED
IC1 & IC2 Pt# 315-0922A	47 pf or 100 pf	NOT INSTALLED
IC1 & IC2 Pt# 315-0988	100 pf	NOT INSTALLED

- Two 100 pf capacitors have been incorporated into the 32X VA2 version.
- Two capacitors are added to the 32X VA0/VA1 versions as per the above chart

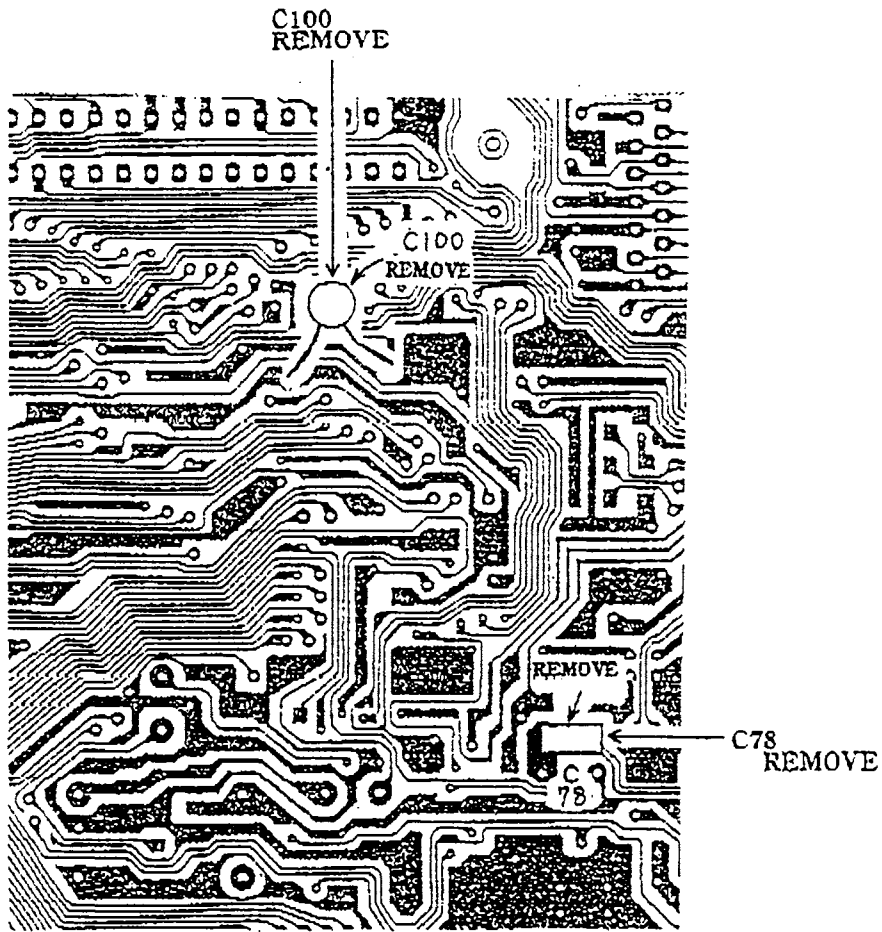
Rear side (termination side) of MD1(VA4) Circuit Board.

Modification for lock up problem experienced with when 32X is used in combination with MD 1 (VA4) version.

The signal quality of the VCLK signal has been identified as the problem area. By removing two capacitors in the VCLK signal line signal quality is greatly improved.

Remove C78 and C100.

Also be sure to perform the MD 1 (VA4) version screen shake modification as this also has a positive affect on this lock up problem.

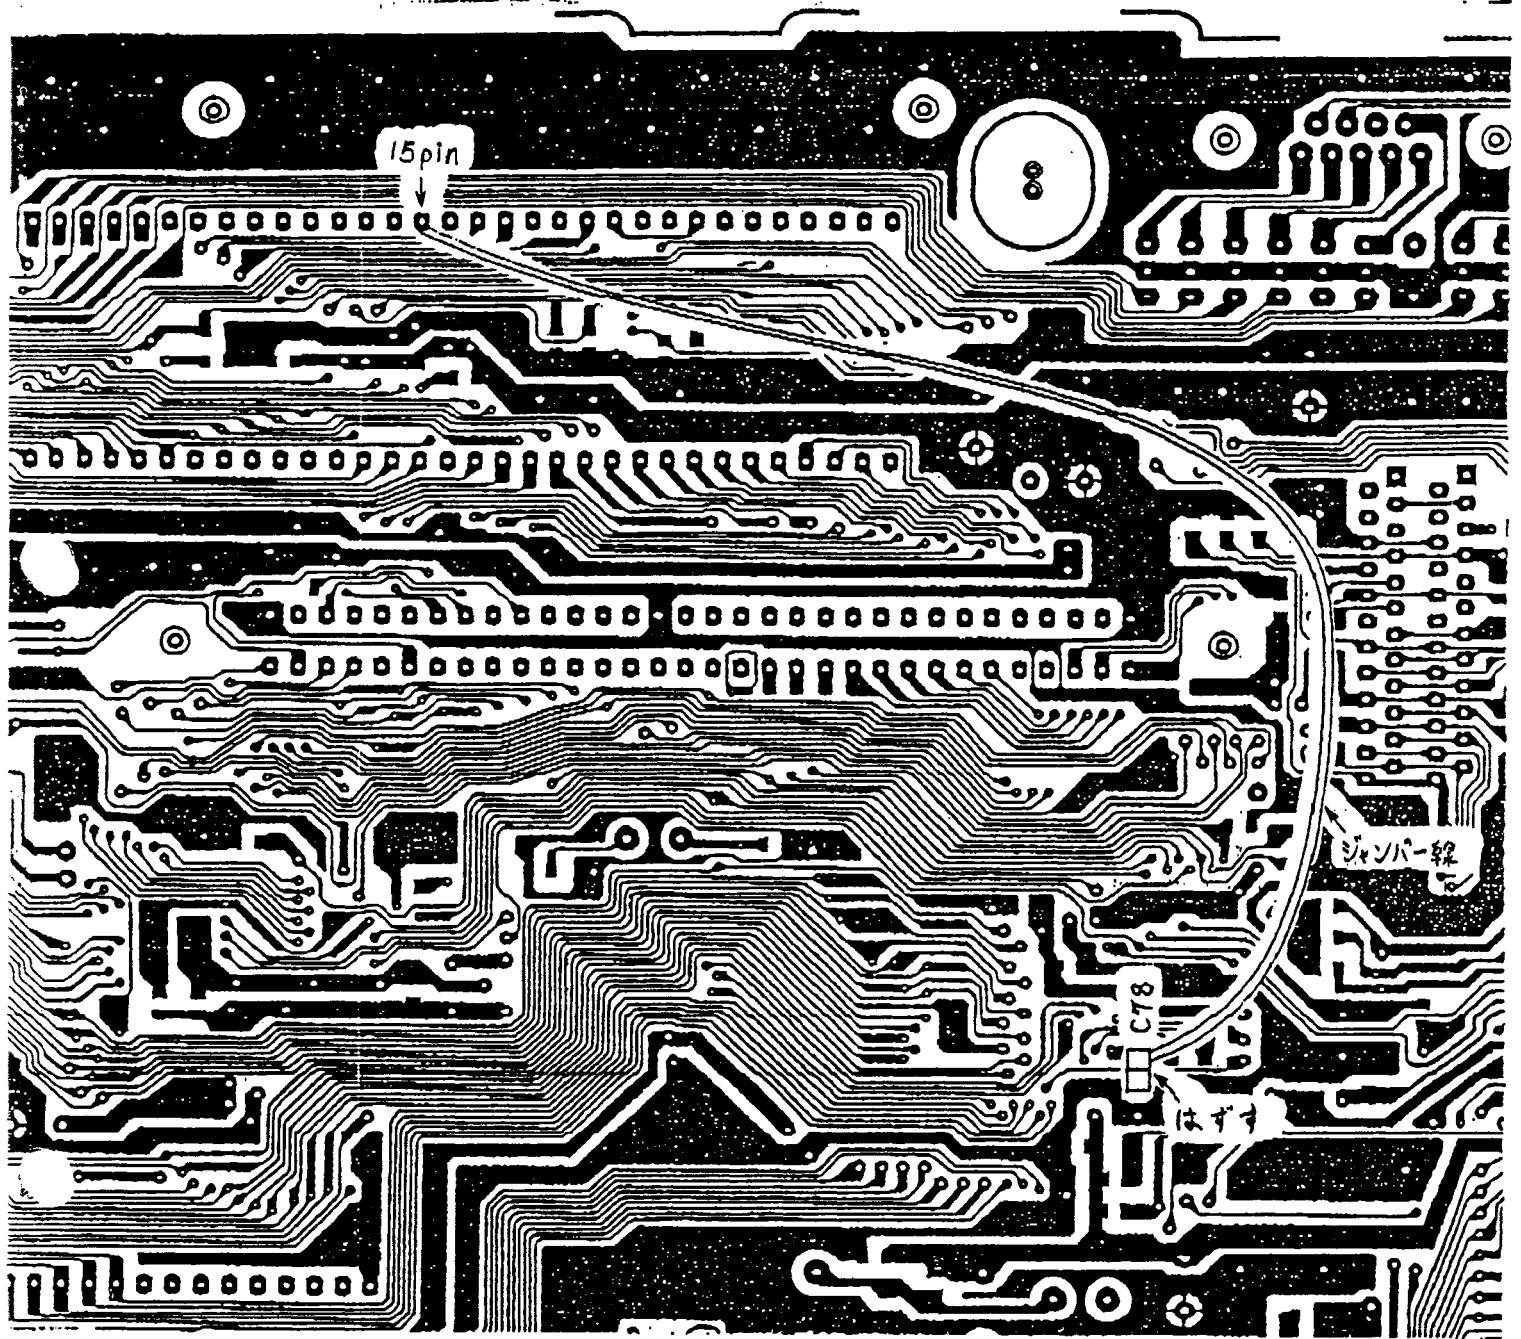
MD1 VA5, VA6 改造方法 (片面パターン図)

Modification for lock up problem seen with some 32X units when used in combination with MD1 (VA6.0, 6.5 or 6.8).

The signal quality of the VCLK signal has been identified as the problem area. By removing one capacitor and adding a jumper line in the VCLK signal line, signal quality is greatly improved.

Remove C78 and add a jumper line from IC 1, pin 15 to the signal side of the pad where C78 has been removed.
